Use of Scanning Electron Microscopy and Energy Dispersive X-Ray Analysis (SEM-EDXA) in Identification of Foreign Material on Bullets

REFERENCE: DiMaio, V. J. M., Dana, S. E., Taylor, W. E., and Ondrusek, J., "Use of Scanning Electron Microscopy and Energy Dispersive X-Ray Analysis (SEM-EDXA) in Identification of Foreign Material on Bullets," *Journal of Forensic Sciences*, JFSCA, Vol. 32, No. 1, Jan. 1987, pp. 38-47.

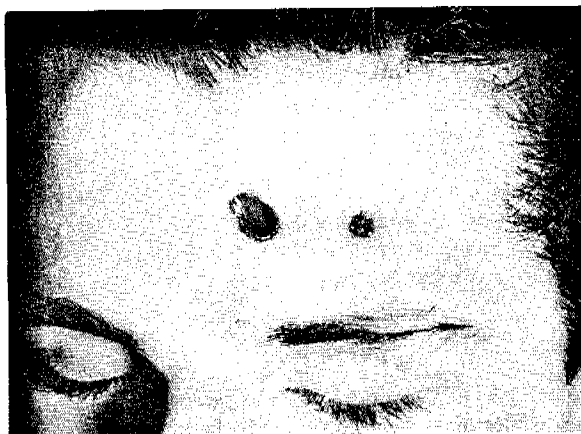
FIG. 1—Ovoid entrance wound of forehead with small exit wound lateral to entrance.

At autopsy, the deceased had a single ovoid, 10- by 5-mm, gunshot wound of the left forehead, 19 mm (3/4 in.) to the left of the midline (Fig. 1), with no blackening or powder tattooing of the surrounding skin. Just lateral to the entry wound there was a smaller, crescent-shaped wound which was produced by a fragment of lead stripped from the bullet as it entered the skull. This fragment traveled subcutaneously and exited at the crescent-shaped wound. The main part of the bullet perforated the left half of the frontal bone, producing an oval defect with beveling of the inner table of the skull and multiple linear fractures radiating from the entry site. The bullet then passed through the left frontal and temporal lobes and struck the left temporal bone where it produced a small, depressed fracture. The flattened and deformed copper coated .22 caliber bullet was recovered from the occipital lobe. White granular material was adherent to the tip of the bullet. Examination of the weapon revealed a single-action .22 caliber revolver loaded with five live and one spent .22 caliber Long Rifle cartridges.
